INDOOR AIR QUALITY ASSESSMENT

**J.W. Martin Elementary School
9 Landry Avenue
North Attleborough, Massachusetts**

Prepared by:
Massachusetts Department of Public Health
Bureau of Environmental Health
Emergency Response/Indoor Air Quality Program
June 2007

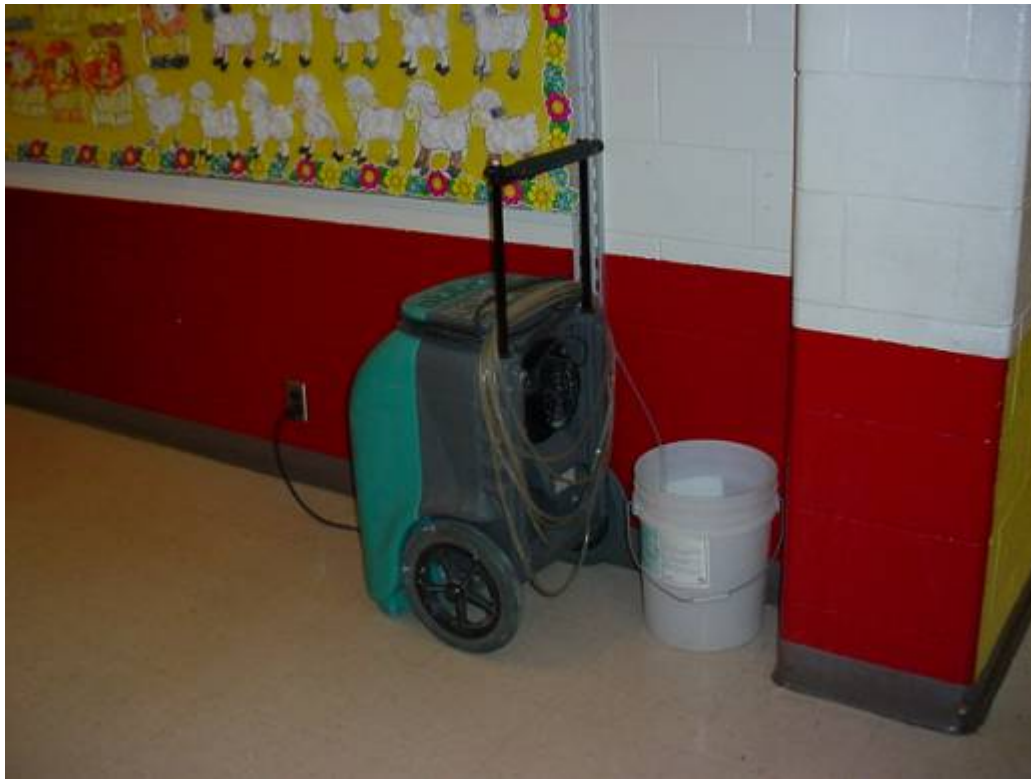
Picture 1

wallboard and ceiling tiles were removed so that air from the fans could be directed into the ceiling plenum (Pictures 1 through 4).

Dehumidifier in Hallway Draining into Bucket

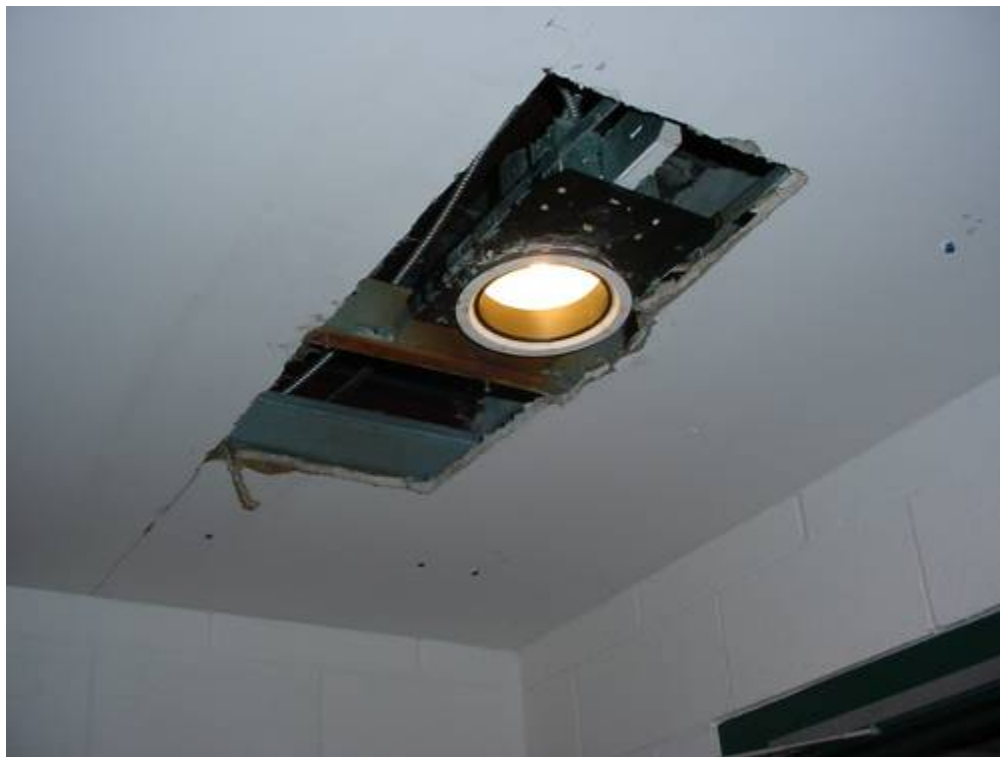
Picture 2

Water Damaged Gypsum Wallboard Ceiling Removed

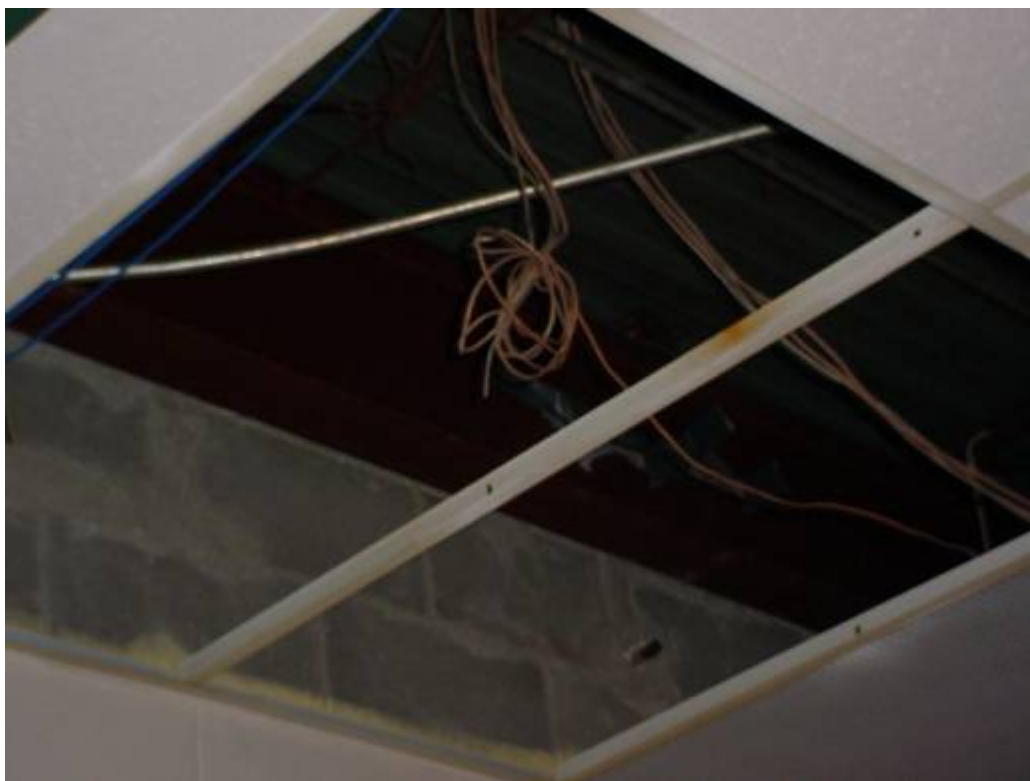
Picture 3

Water Damaged Ceiling Tiles Removed to Assist in Drying Plenum

1. Continue with plans for roof and ceiling tile systems replacement. Once completed repair/replace any remaining water-stained ceiling tiles and other building materials. Examine the area above and around these areas for mold growth. Disinfect areas of water leaks with an appropriate antimicrobial.

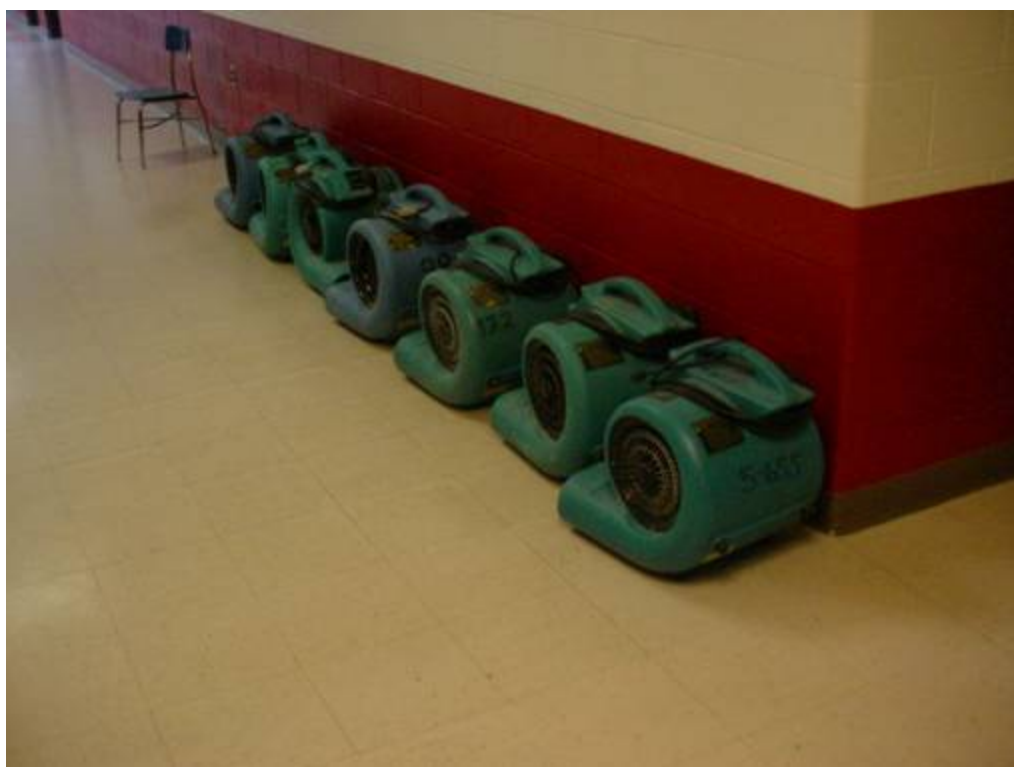
Picture 4

On Friday March 23, 2007 Mr. Holmes spoke with Mr. Luce about potential moisture and other environmental conditions as well as health complaints. Mr. Holmes concurred with Mr. Luce that the most likely source of irritation was the movement of particulates that accumulate in the ceiling plenum by drying fans. Mr. Luce stated that upon complaint from building occupants on Thursday March 22, 2007, all fans were deactivated to prevent further aerosolization of particulates. Mr. Luce reported that complaints had ceased after the deactivation of fans. Mr. Holmes recommended that all areas where fans had been employed should be thoroughly cleaned over the weekend using HEPA filtered vacuum cleaners and/or wet wiping techniques to remove settled particulates prior to the opening of school on Monday March 26, 2007.

Industrial Drying Fans Stationed in Hallway

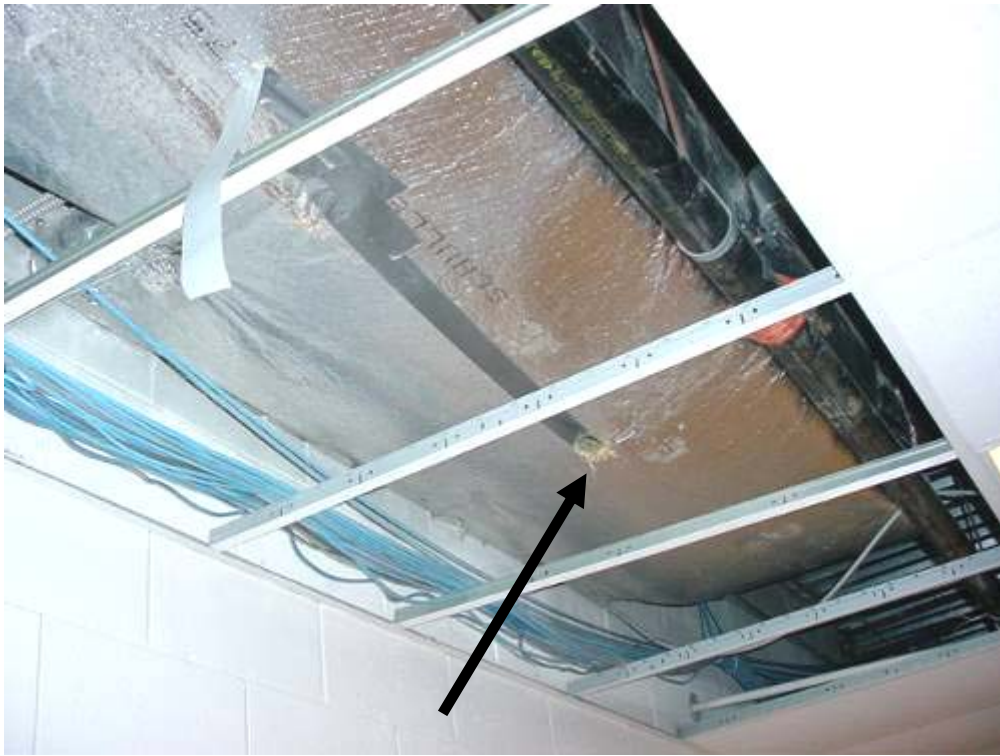
Picture 5

Elevated moisture readings were measured in insulation in the main hallway outside the computer lab and in the teachers workroom/copier room (Pictures 5 and 6).

Wet Insulation in Main Hallway outside Computer Room, Note Hole in Bottom of Insulation to Provide Drainage

2. Replace water damaged ductwork insulation in the main hallway outside the computer room, teacher's workroom and in any additional areas where found saturated. Examine the area above and around these areas for mold growth. Disinfect areas of water leaks with an appropriate antimicrobial.

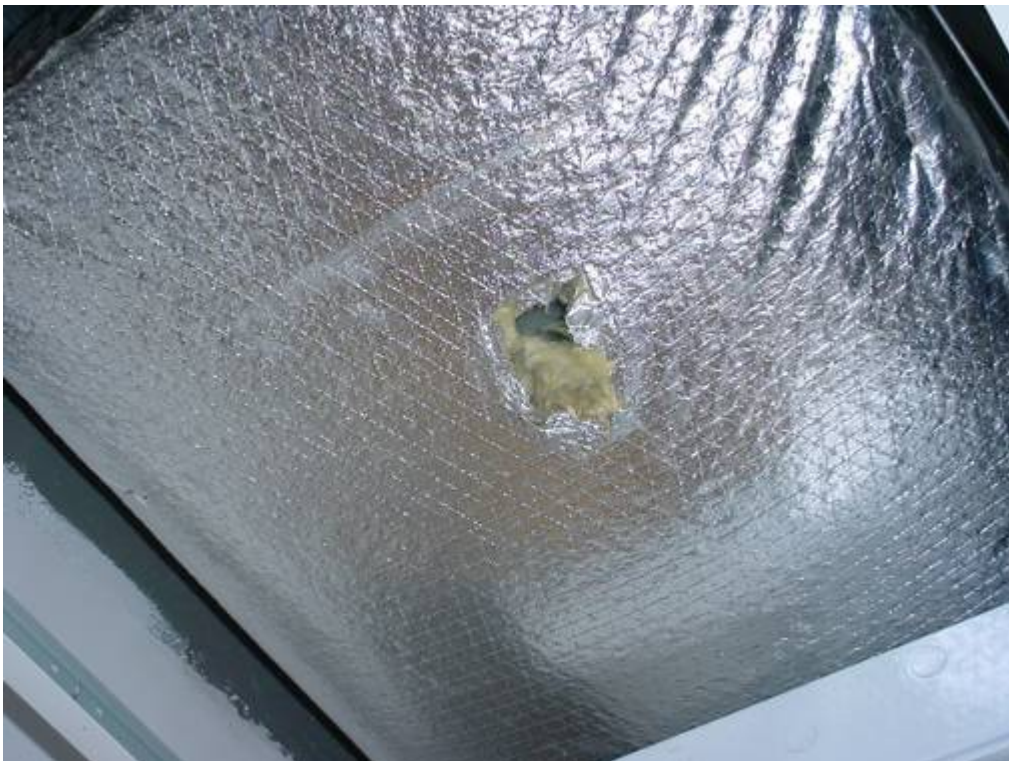
Picture 6

Water Damaged Insulation, Note Hole to Provide Drainage

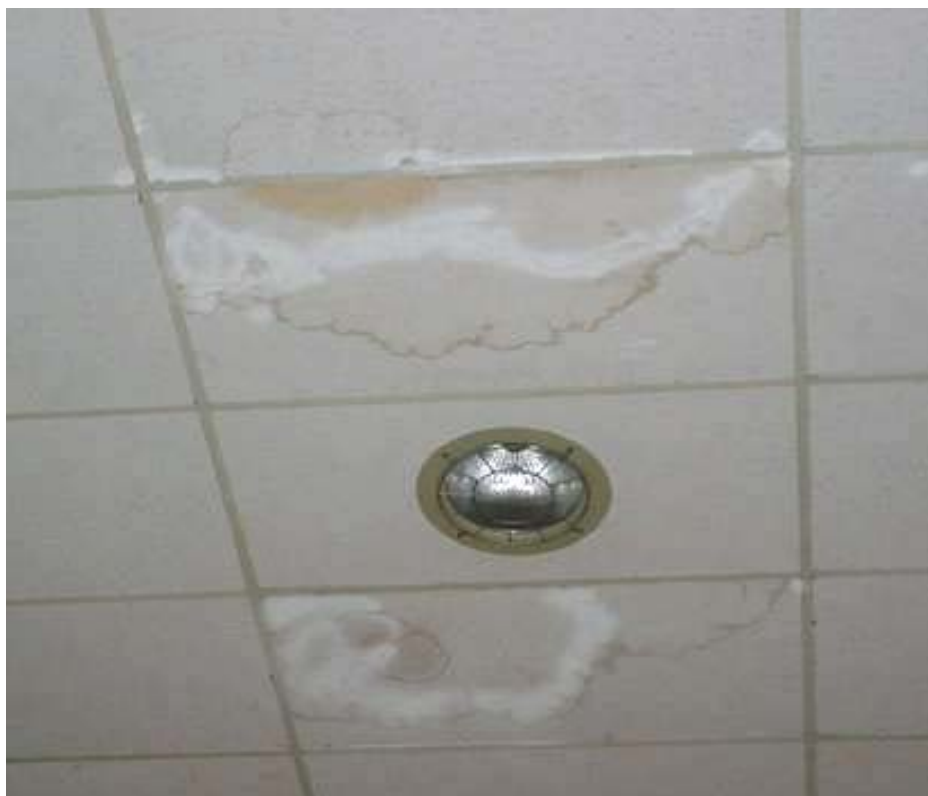
Picture 7

Water Damaged Ceiling Tiles in Cafeteria

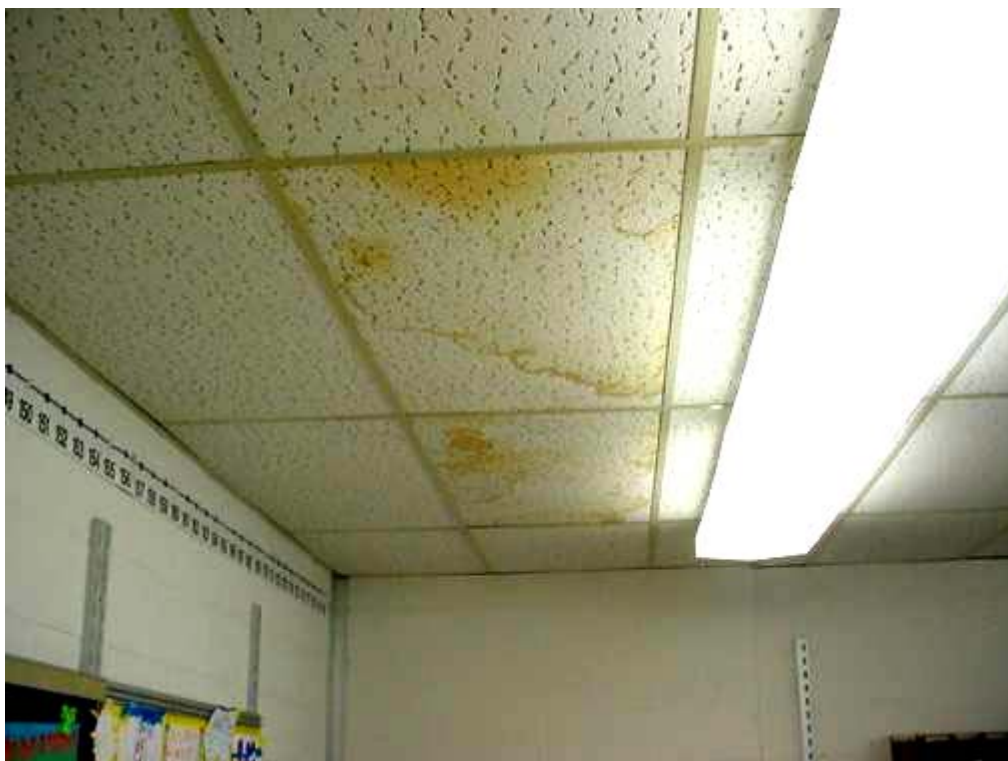
Picture 8

Water Damaged Ceiling Tiles in Classroom

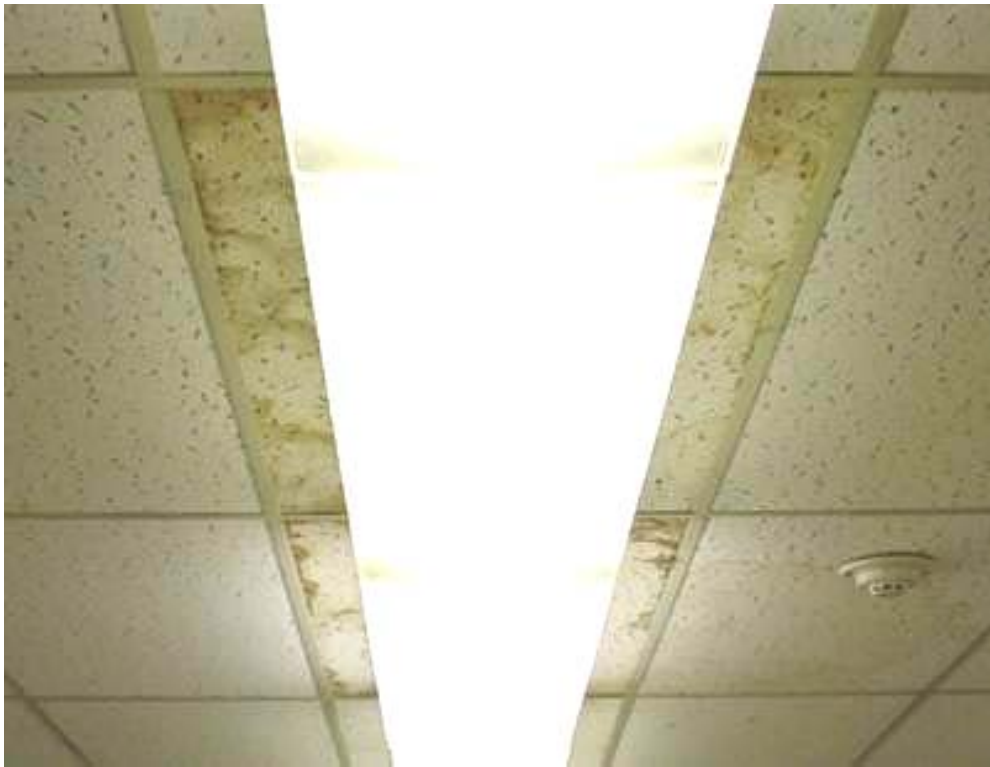
Picture 9

Water Damaged Ceiling Tiles in Classroom

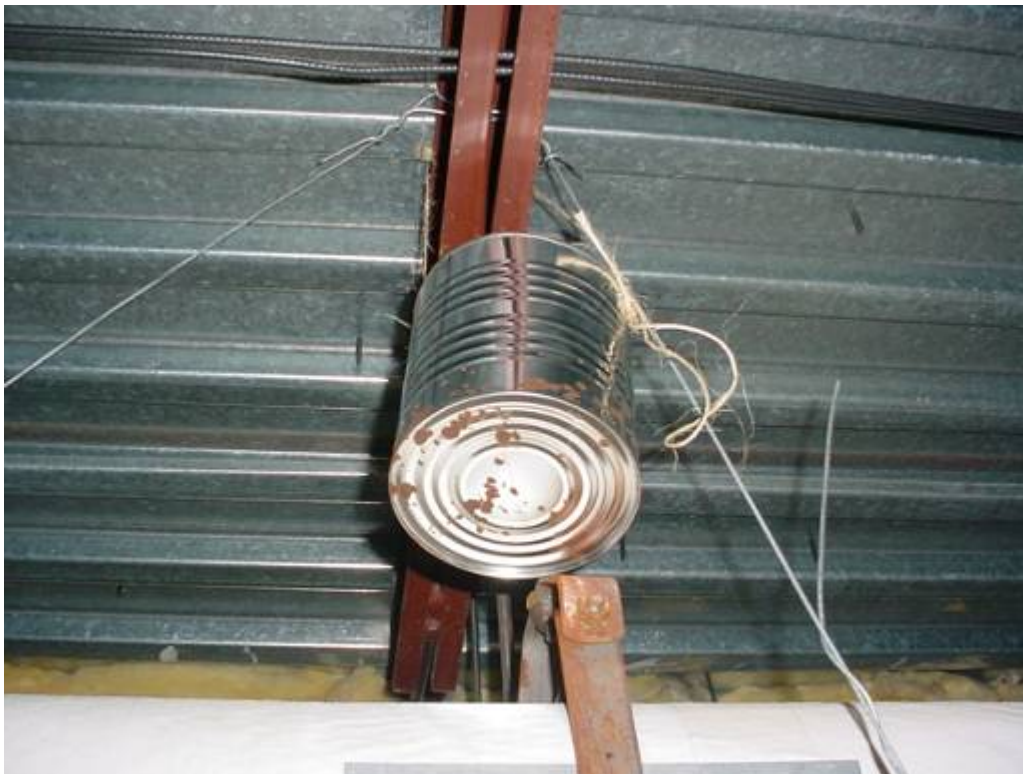
Picture 10

Paint Can Suspended above Ceiling Tile System to Collect Roof Leak

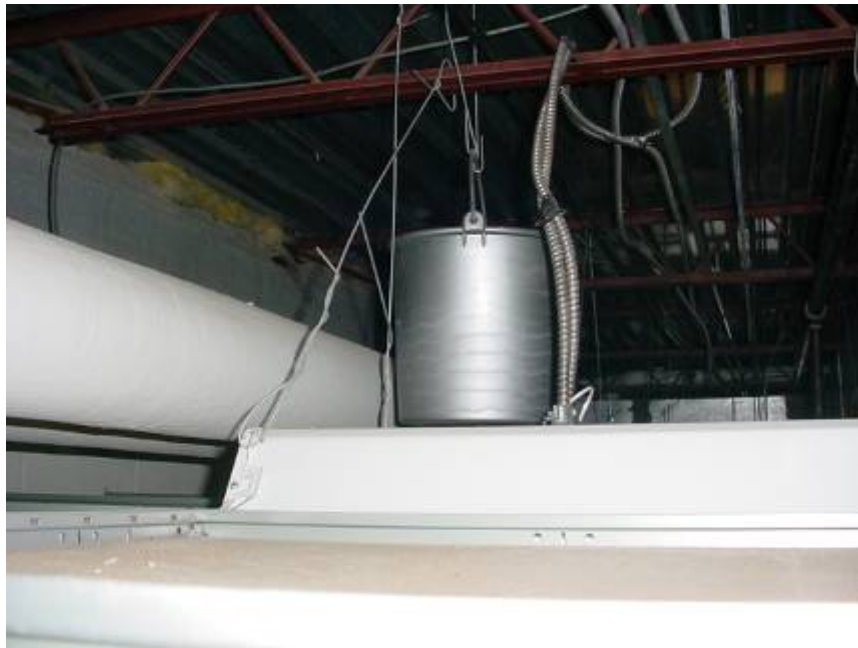
Picture 11

Bucket Suspended above Ceiling Tile System to Collect Roof Leak

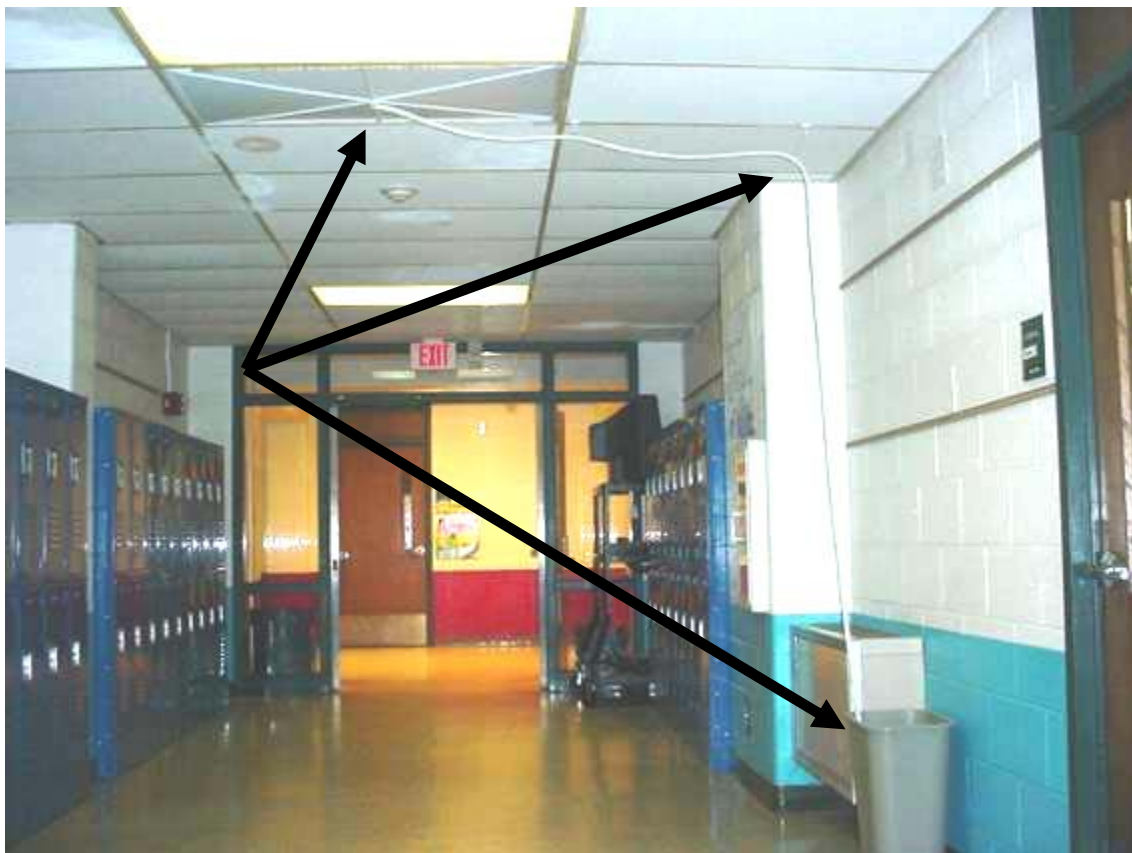
Picture 12

Interior Drainage System, Note Tile and Drainage Hose Emptying into Trash Container on Floor
